Environmental Assessment

Access Culvert Replacement

Lechuguilla Cave

April 1999

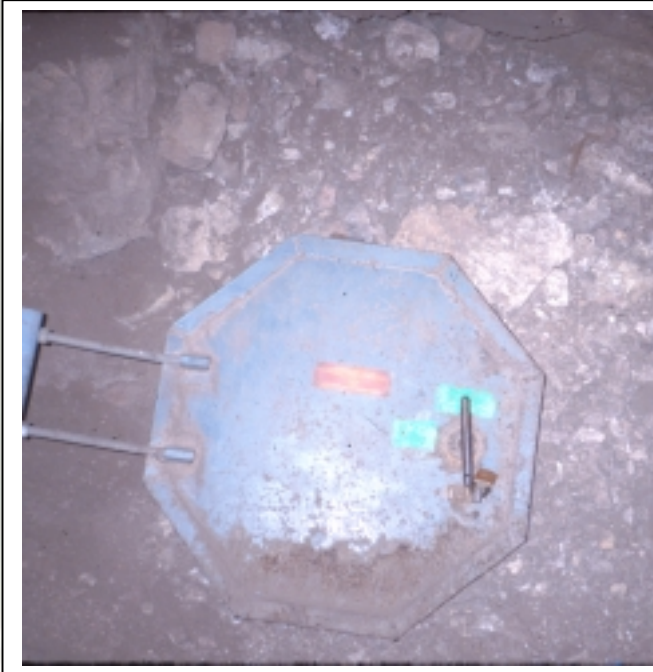
1. The lid is unsealed and permits undesirable airflow into and out of the cave coincident with natural barometric pressure differentials.

2. The lid permits large exchanges of air during entry and exit by personnel coincident with natural barometric pressure differentials.
 3. The lid security lock system is removed during expeditions and the cave is subject to unauthorized entry with the possibility of inadvertently locking an unauthorized entrant in the cave.

Figure 1
The lid of the culvert,
latching handle, and
counter weight on the
left.

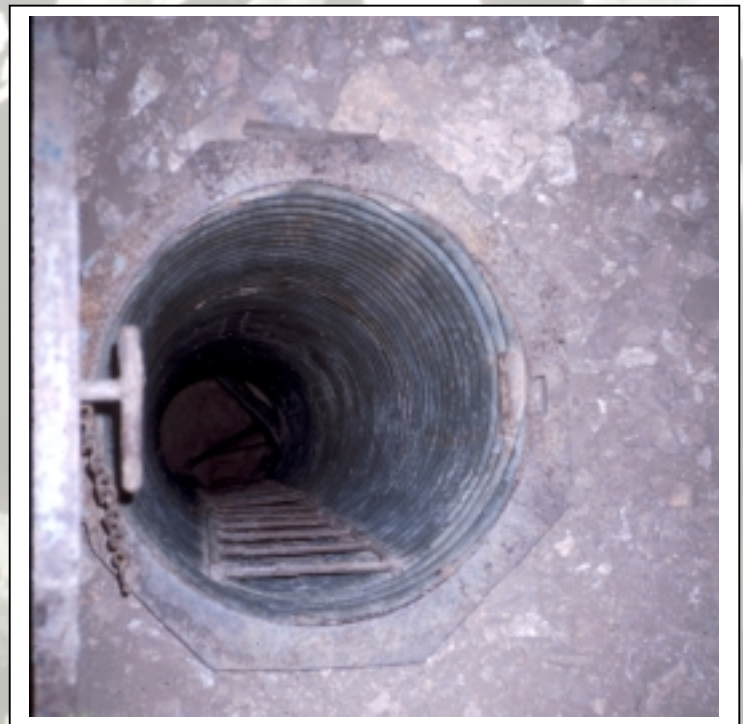
Figure 2
Looking into the culvert with
the lid open.

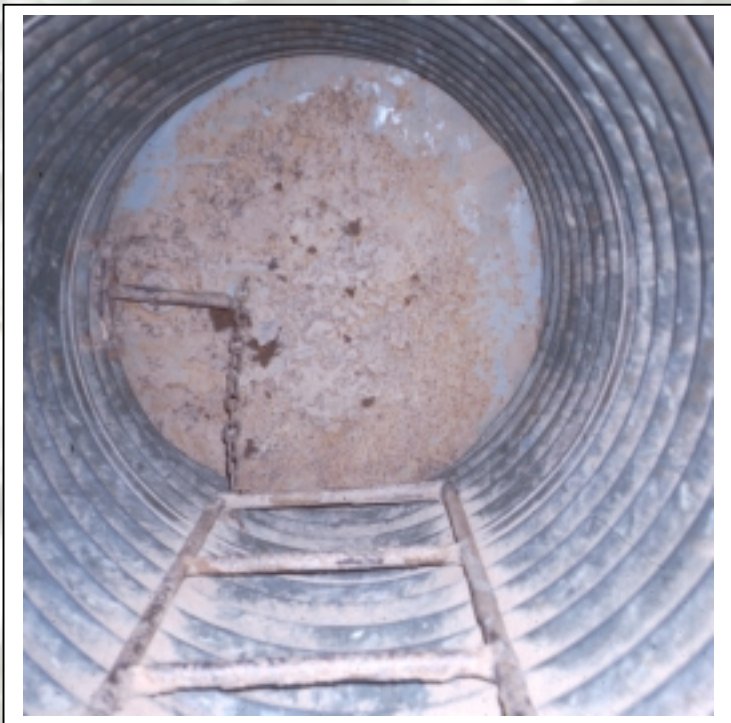
Figure 3
Inside the culvert looking
at the closed lid.

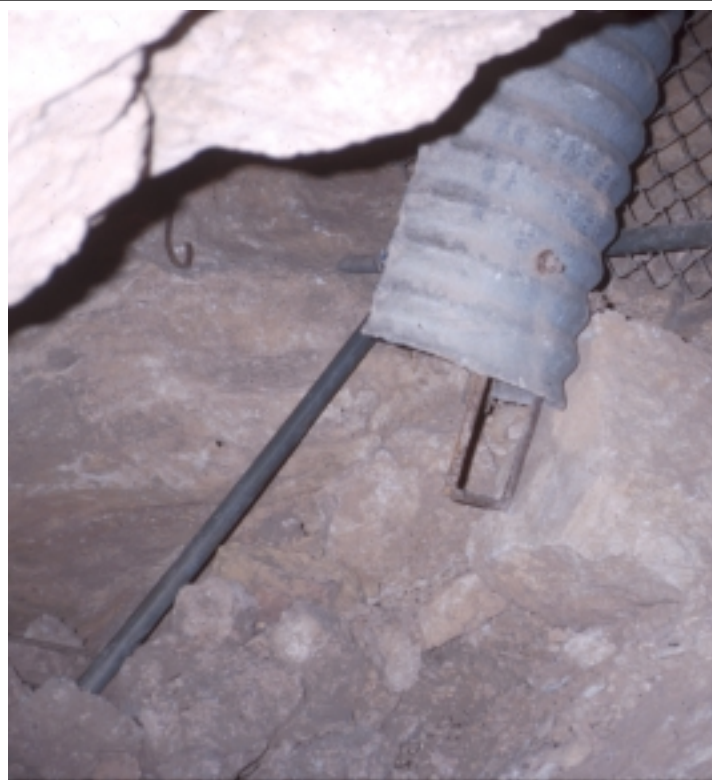
8. The cave environment is severely corrosive to all of the other entrance material including bracing and fencing. One of the galvanized braces has already broken under stress.

Figure 4
Bottom of the “half culvert”.
Note the broken support lying
below and to the left.

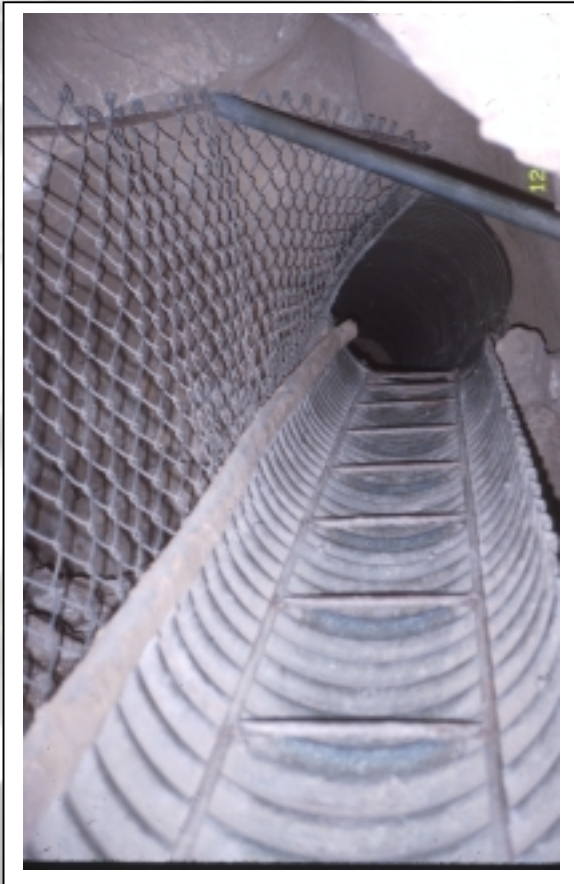
Figure 5
The fencing on the left supports
breakdown from collapsing on
cavers.

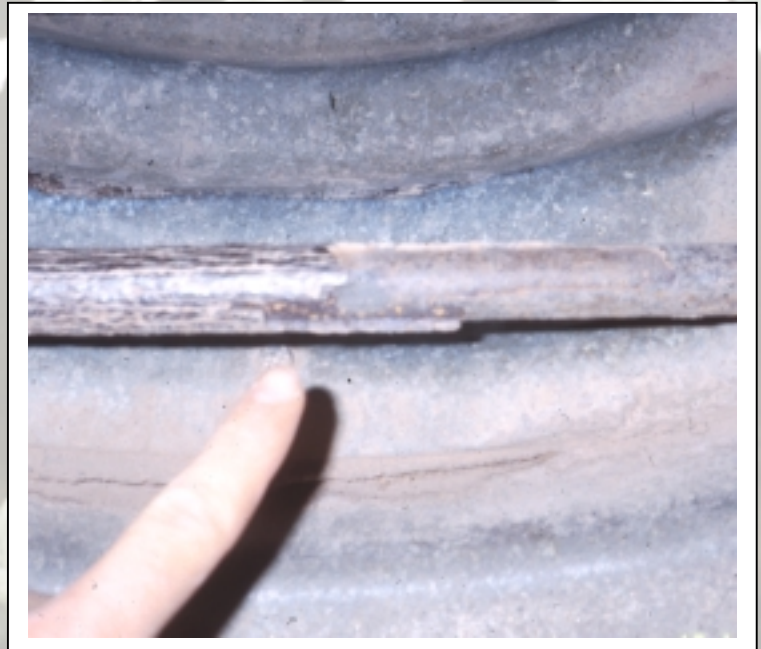
5. The galvanized corrugated metal culvert has experienced surface and structural corrosion.
 6. The unprotected steel ladder is severely corroded, on some rungs having lost half their mass, and constitutes a safety hazard.

Figure 6
The exfoliating rust on the
rungs of the ladder.

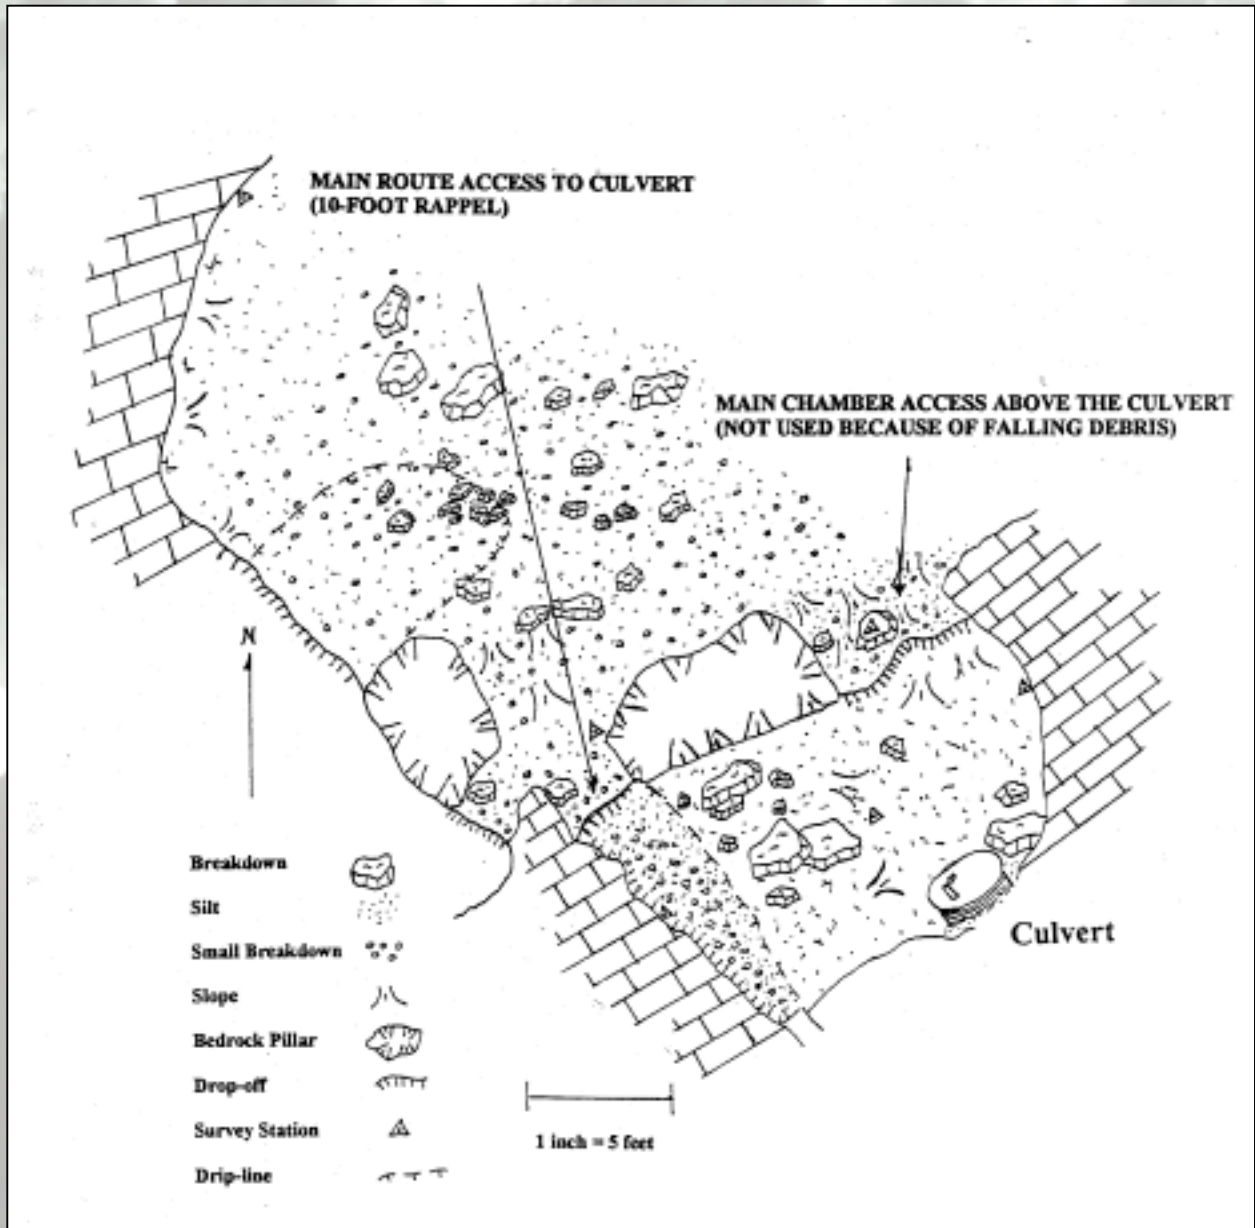
Figure 7
Plan view of the entrance floor and the lower culvert area.

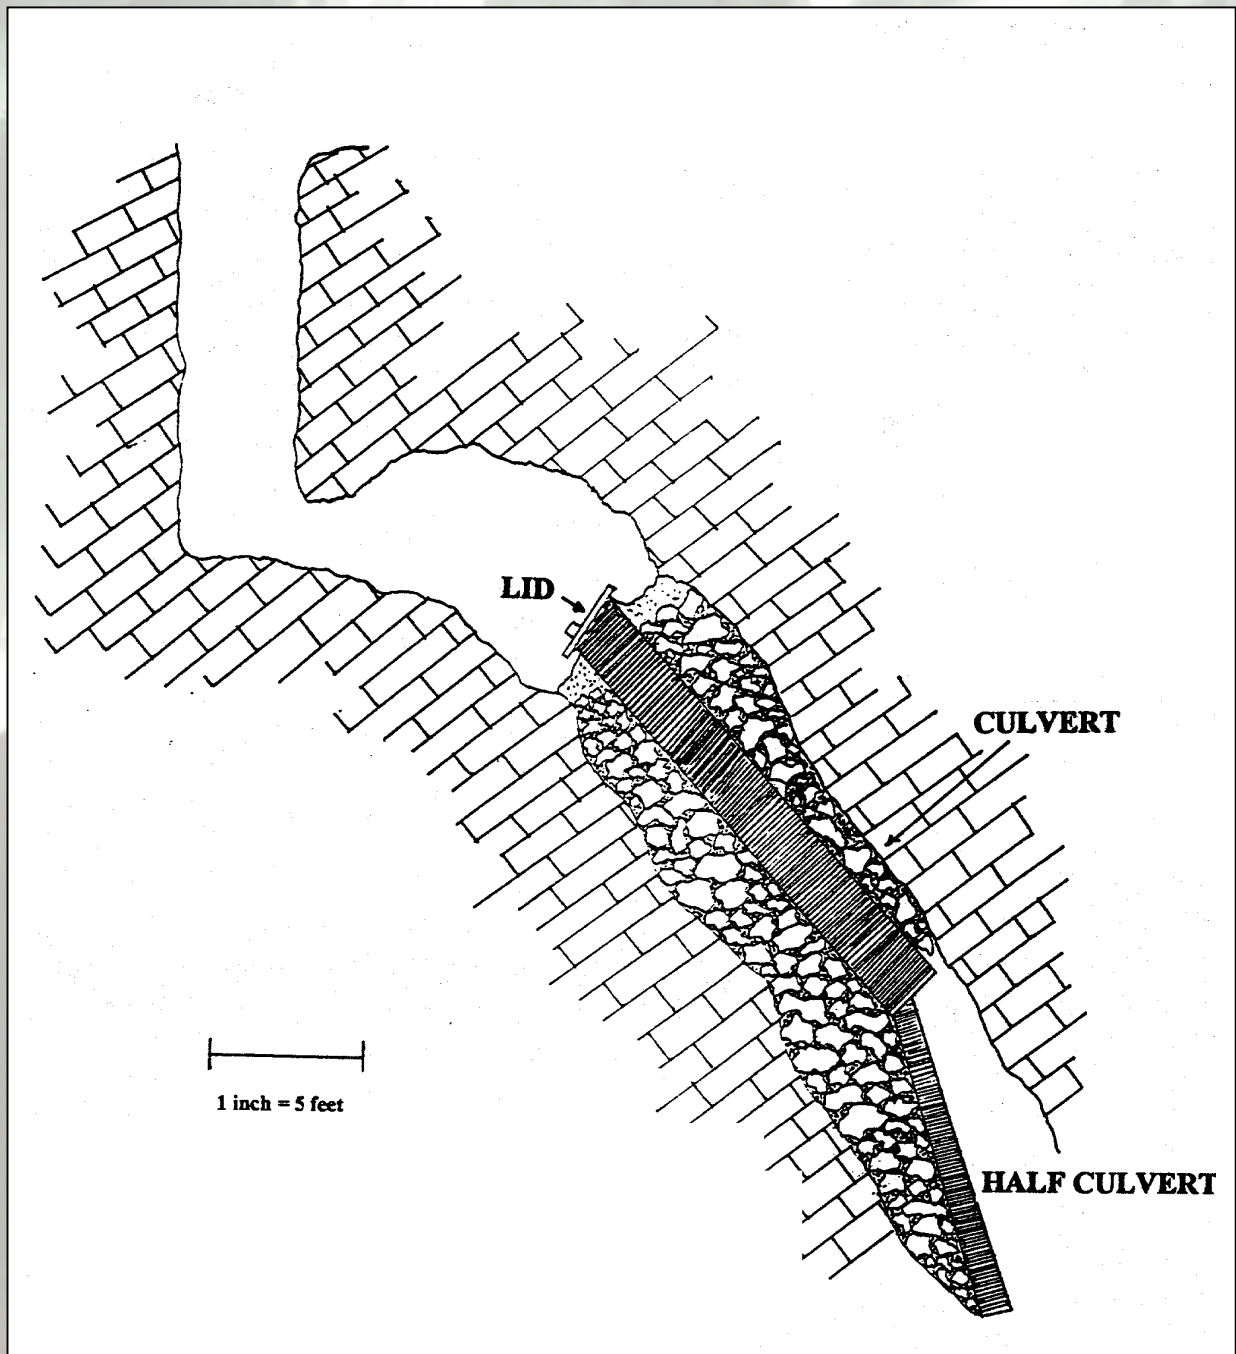
Figure 8
Profile of the present access culvert and its relation to bedrock and alluvial backfill.

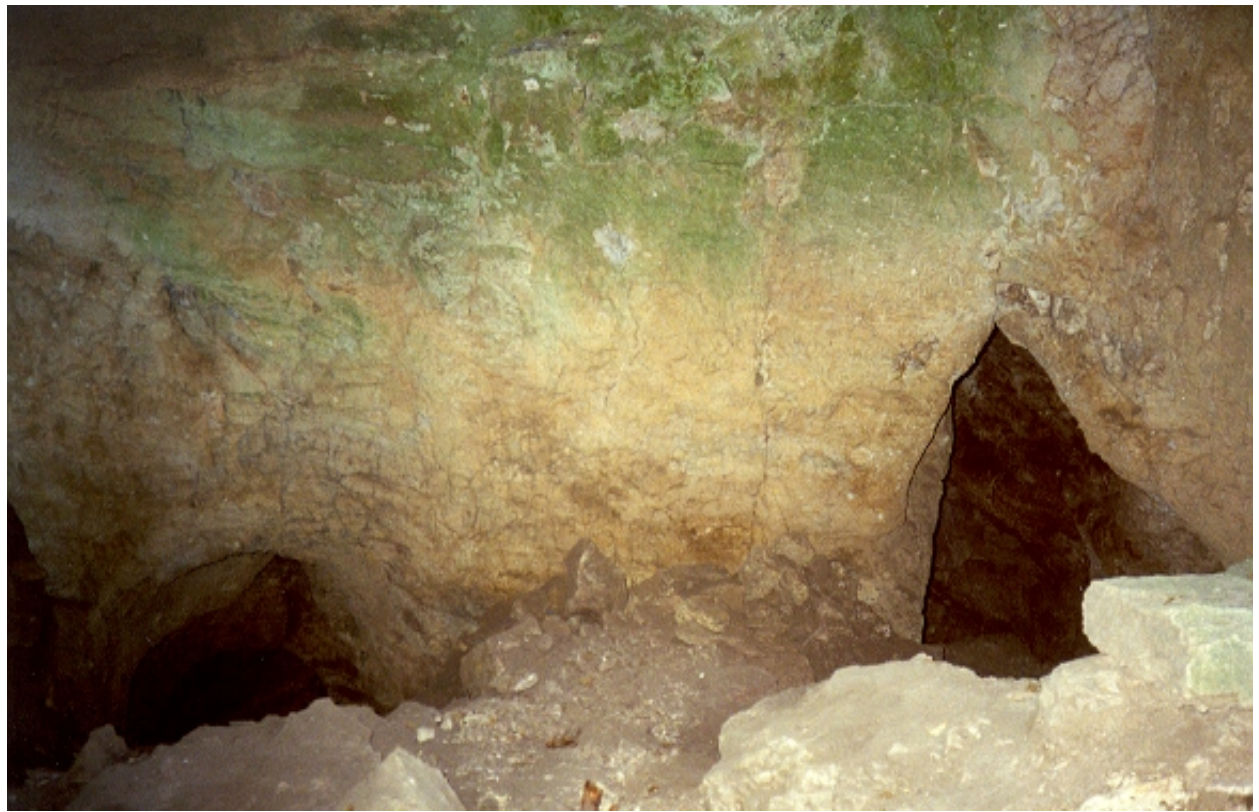
Figure 13

Directly above the lid of the culvert, approximately 15 vertical feet, is the left access to the entrance chamber. This vertical access is a major concern, and may present a severe safety hazard. During infrequent desert downpours, sediment and rocks, sometimes very large rocks, are dislodged and fall on to the lid of the culvert. Prior to entry, this causes the inconvenience of digging debris from around the lid. However, after the entry by an expedition, it could conceivably trap personnel in the cave.

Photograph of both accesses to the culvert area. The access on the right is the one used, and the one on the left is directly above the culvert.
